**The Body Comes Off** - Installment 2 – Richard Fingerhut

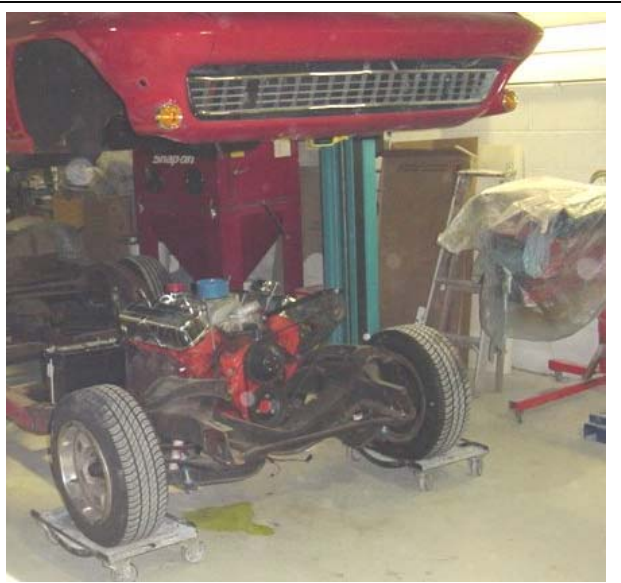
**The body & frame part ways.**

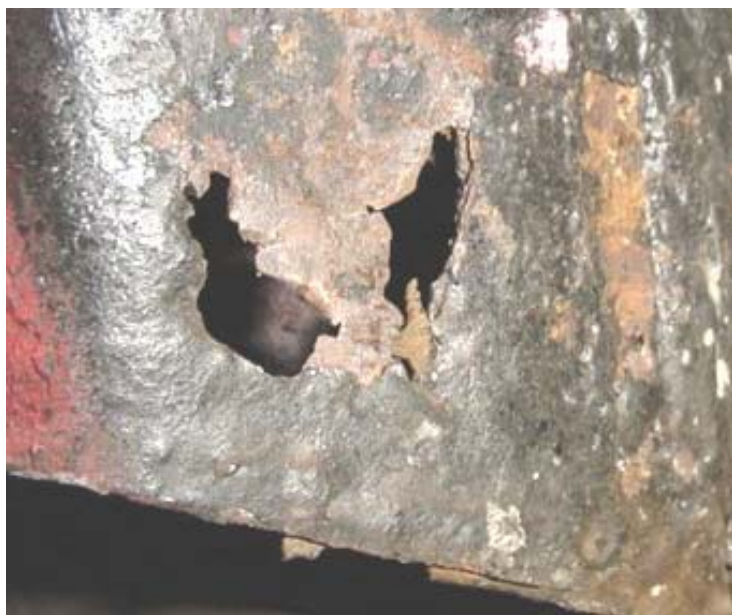
When last I wrote, the body on my '66 was about ready to be lifted off the chassis. This has recently been done, so we can better assess the damage to my frame and wear on the suspension. As expected, the frame was indeed rotted at the usual trouble spots on midyears. Once the frame is completely stripped, it will be blasted to see exactly what needs to be done. Most of the sections have come in, as have many of the other

**The frame was rusted through in places.**

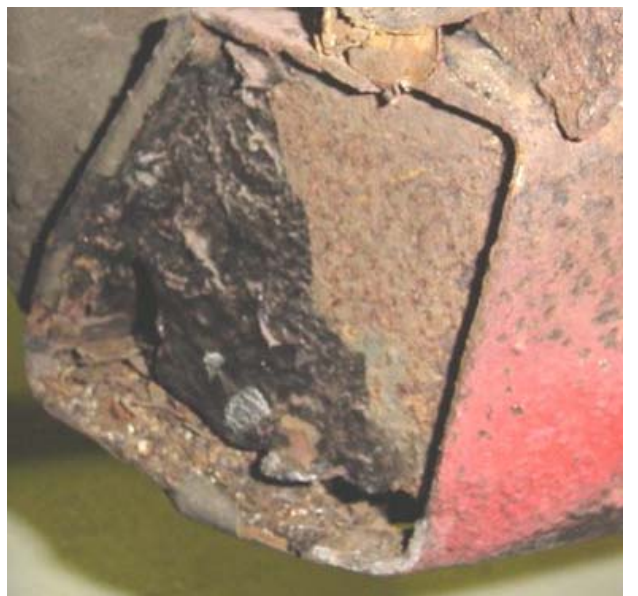
**The frame end rails are rusted also.**

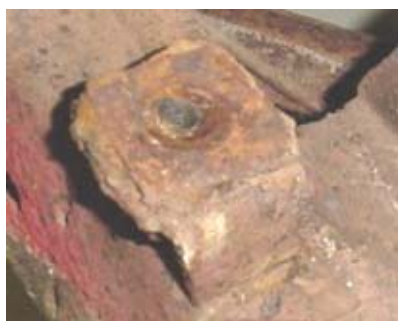
**Body mounts weren't too bad.**
